# Establishing Permanence of Repair Systems for Above Ground Leaks

May 27, 2016

## **Prepared For:**

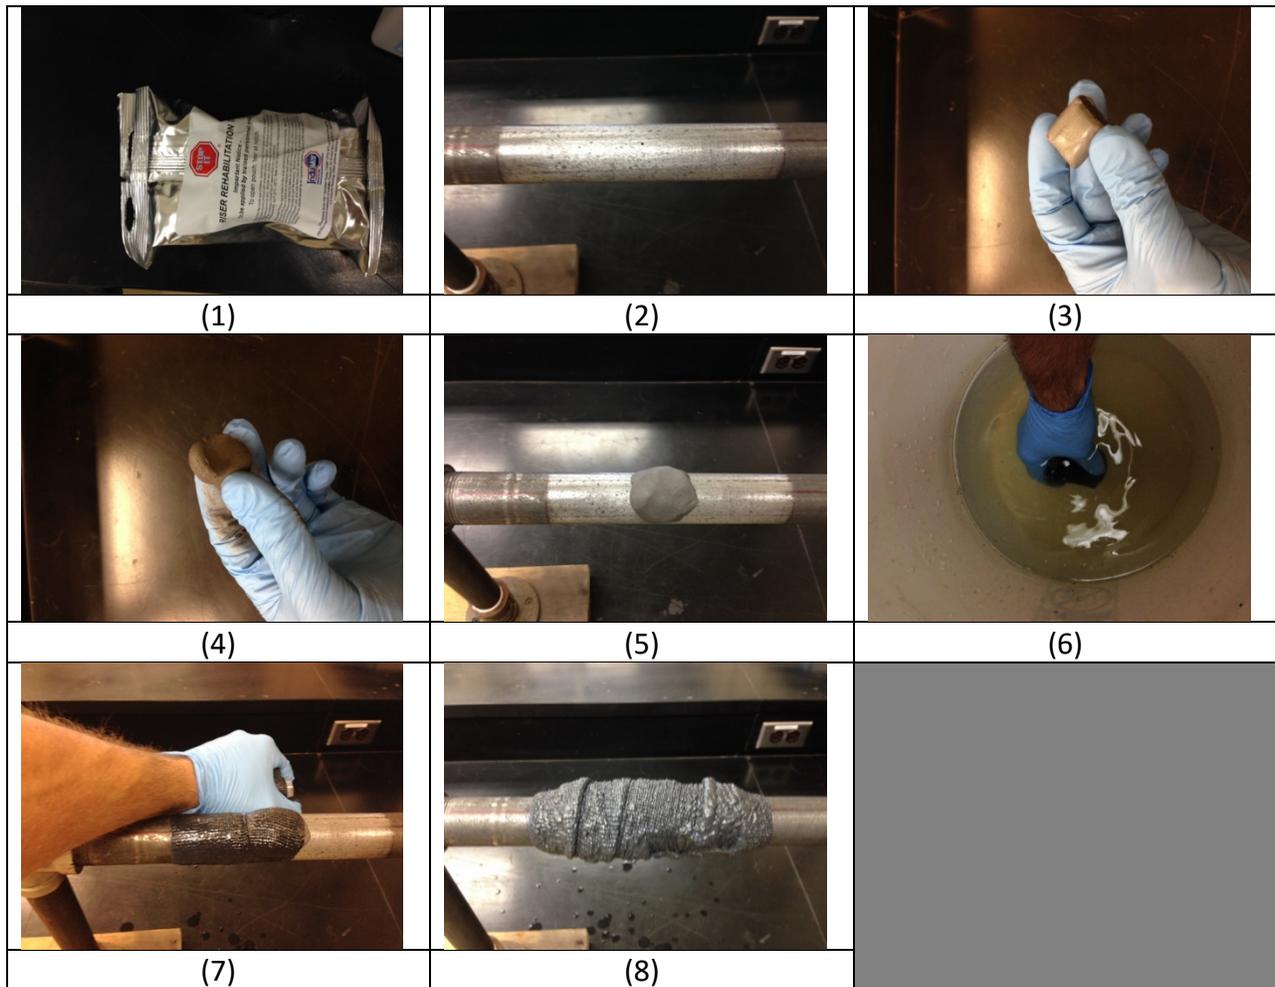
**Figure 1. Example of Stop It Repair**

Stop It is for non-pressurized leak repairs. The repairs were applied to 1" schedule 40 steel pipe samples per the manufacturer's procedure. To simulate a leaking pipe a 1/16" diameter hole was drilled in the center of the pipe and the repair applied without pressure, as shown in **Figure 1**.

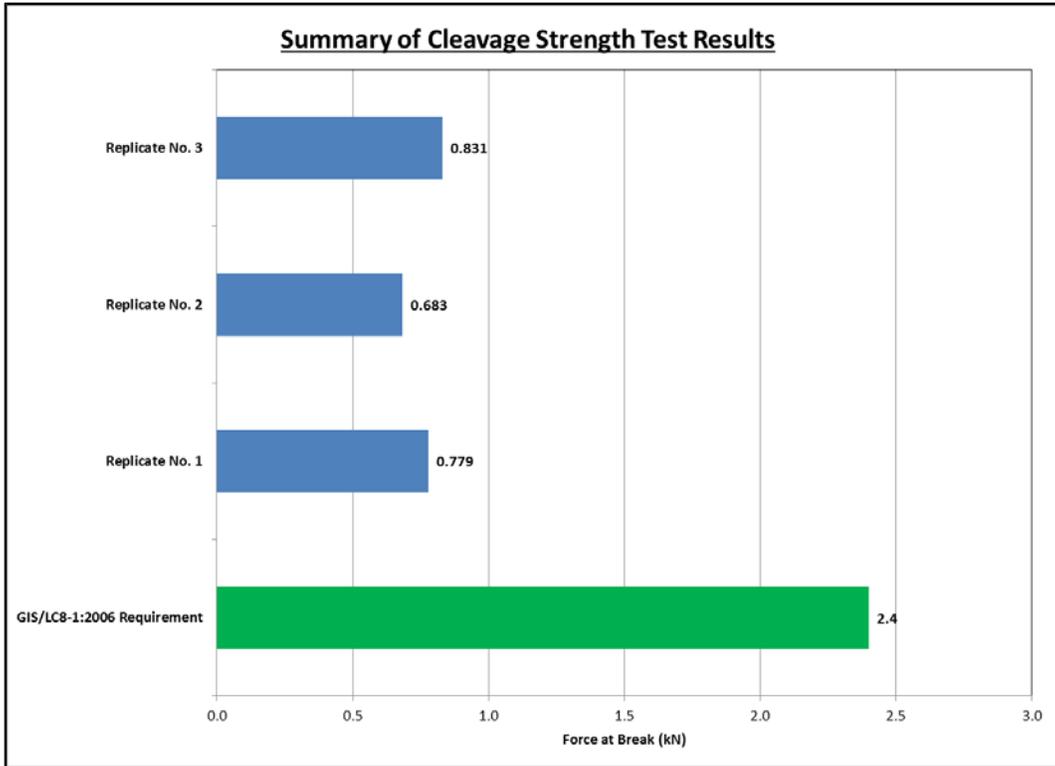
**Figure 2. Summary of Cleavage Strength Test Results (Product #3)**

Cleavage strength testing was performed on Product #3 repair product in accordance with Annex A of GIS/LC8-1:2006. This test is a measure of the shear strength for the repair material. Product #3 was applied to “L” shaped steel sections and cured. The specimens were then stored in a thermo-regulated conditioner at 23°C for 24 hours. Three (3) replicates were prepared and tested. A summary of the test results is provided in **Table 3** and **Figure 2**.

This test was performed by a third party. The test results do not meet the requirements of GIS/LC8-1:2006 which specifies that the cleavage strength of the repair system shall be not less than 2.7 kN from an average of three samples, and any one sample result shall not be less than 2.4 kN.

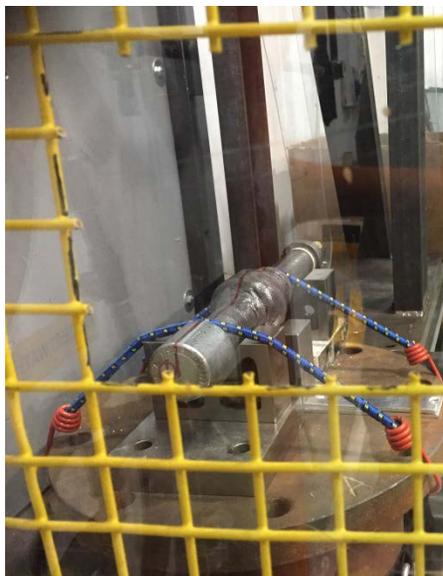
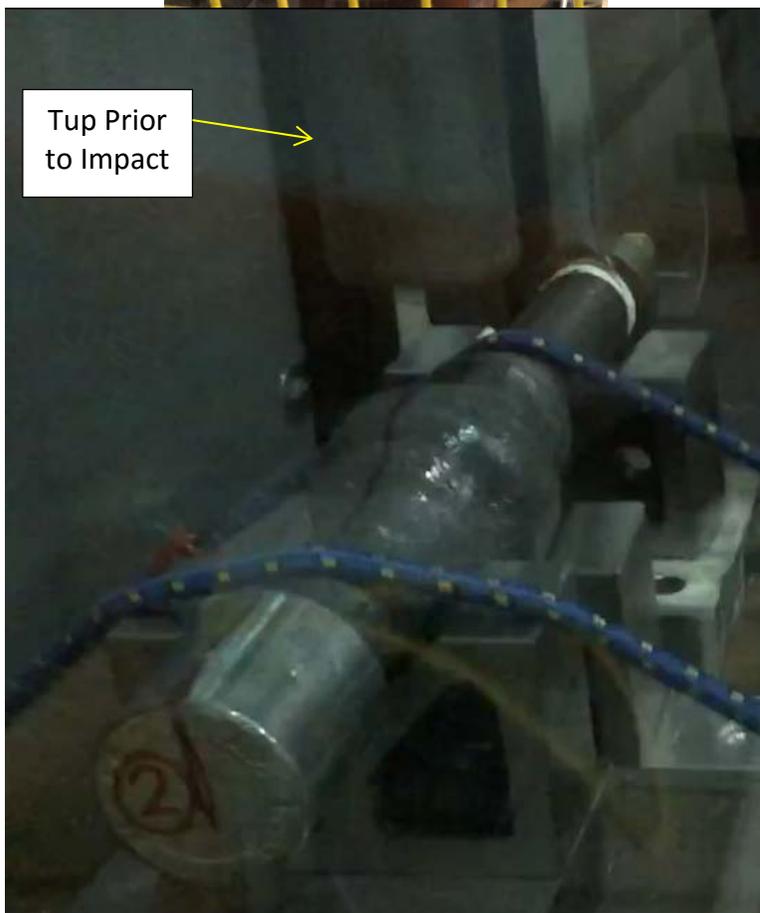
**Figure 3. Impact Test Setup**

Impact testing was performed in general accordance with GIS/LC8-1:2006, Clause D.3 to evaluate the capability of the repaired pipe to withstand an impact load of the kind that it might experience during periods where the pipe is still excavated, as follows:

- Three specimens of each repair product were prepared.
- Each repaired specimen was mounted in the impact testing machine as shown in **Figure 3**.
- Each specimen was subjected to a blow of 135 J on the repaired location resulting from dropping a 24 lb tup (free falling weight) from a height of 4.2 ft. The tup nose geometry is provided in **Figure 4**.
- On completion of impact testing each repaired specimen was removed and pressurized to 120 psig for one month or until failure (leakage) occurred.

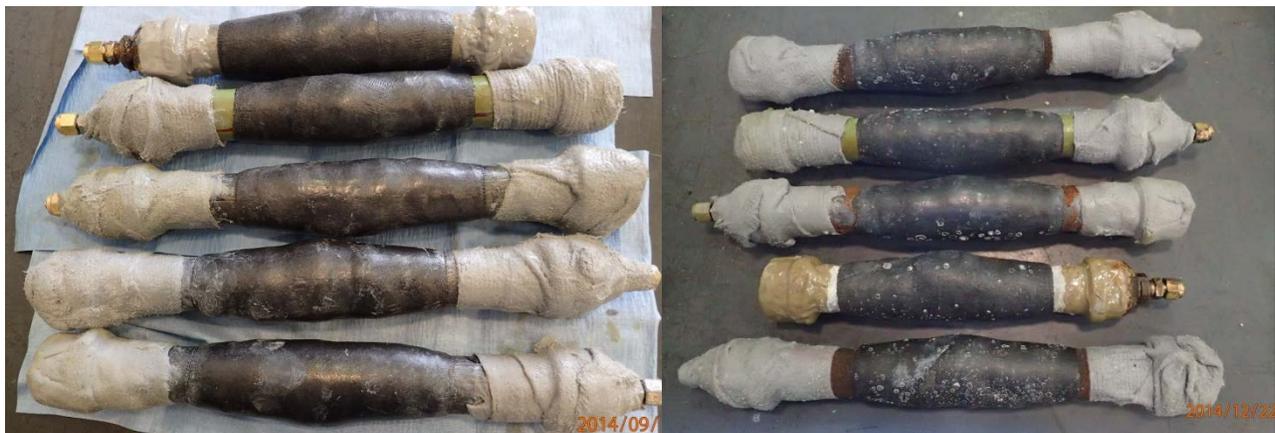
**Figure 5. Repaired Specimens with IPI Stop It before (left) and after (right) Cyclic Corrosion Test**

The test specimens were placed in GTI’s Q-Fog Chamber Model CCT 1100 for 2,000-hour exposure to the CCT-IV cyclic corrosion cycle.

The appearances of the IPI Stop It test specimens before and after testing are shown in **Figure 5**.

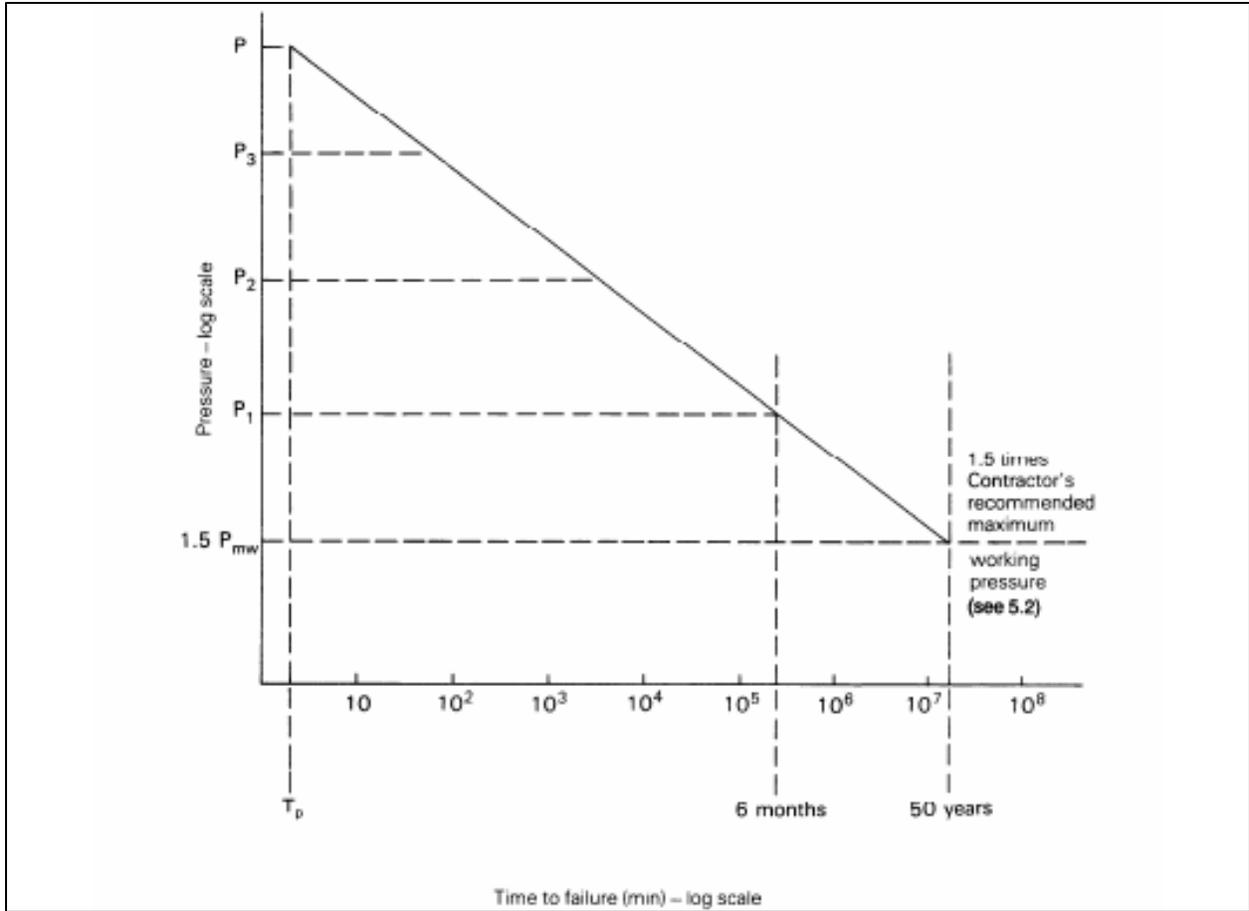
**Figure 6. Pressure/Life Testing<sup>3</sup>**

For each repair system a second set of three specimens was placed on test at room temperature and pressure  $P_1$ .  $P_1$  was determined by drawing a straight line, on a log/log plot of pressure against time, joining the short-term failure point ( $T_p$ ) to the  $1.5 \times P_{max}$  specified maximum working pressure point of 90 psig (1.5 x 60 psig).  $P_1$  is the pressure corresponding to six months on the time axis. An exemplar plot is provided in **Figure 6**.

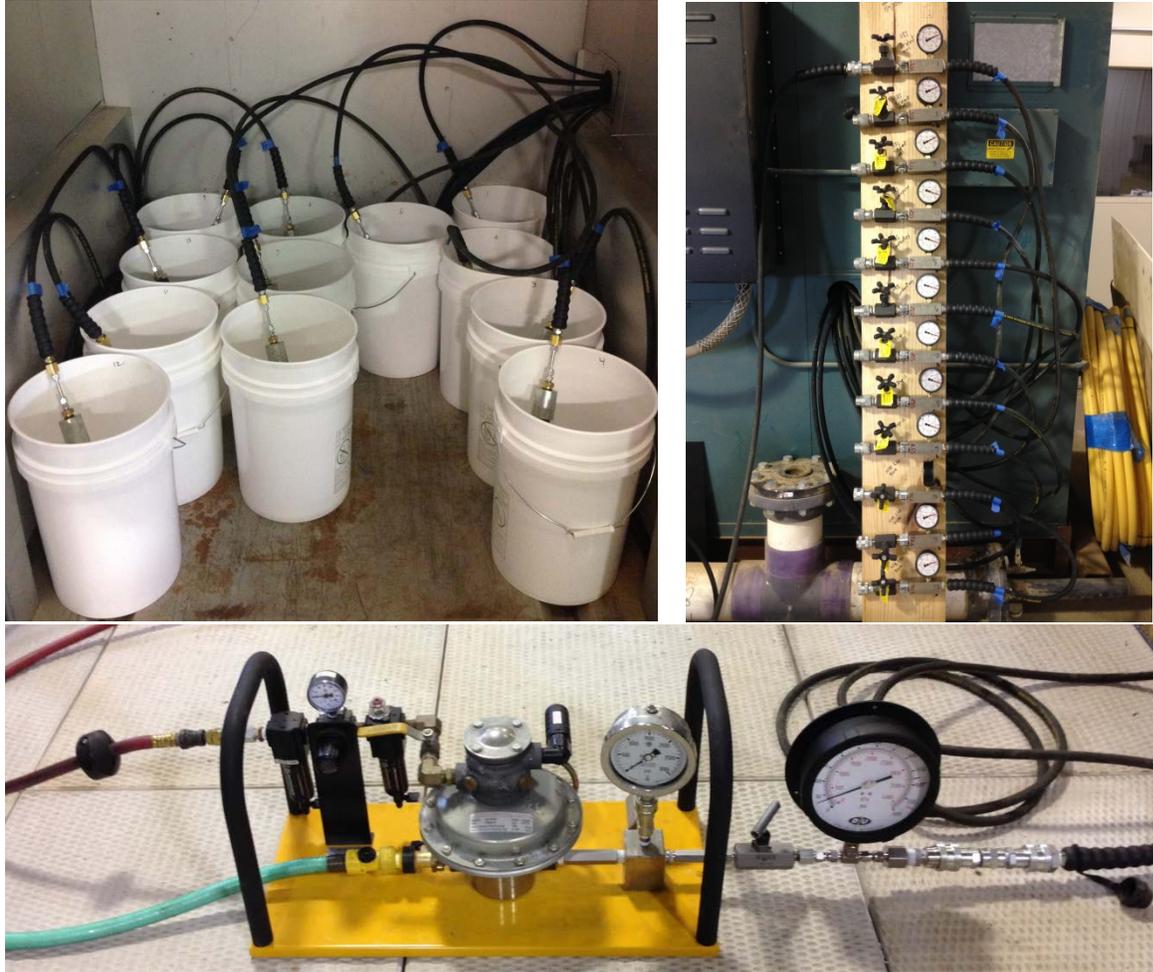
**Figure 7. Long-Term Pressure Testing Setup**

The repaired specimens were tested for six months or until failure occurred. The test setup is shown in **Figure 7**.

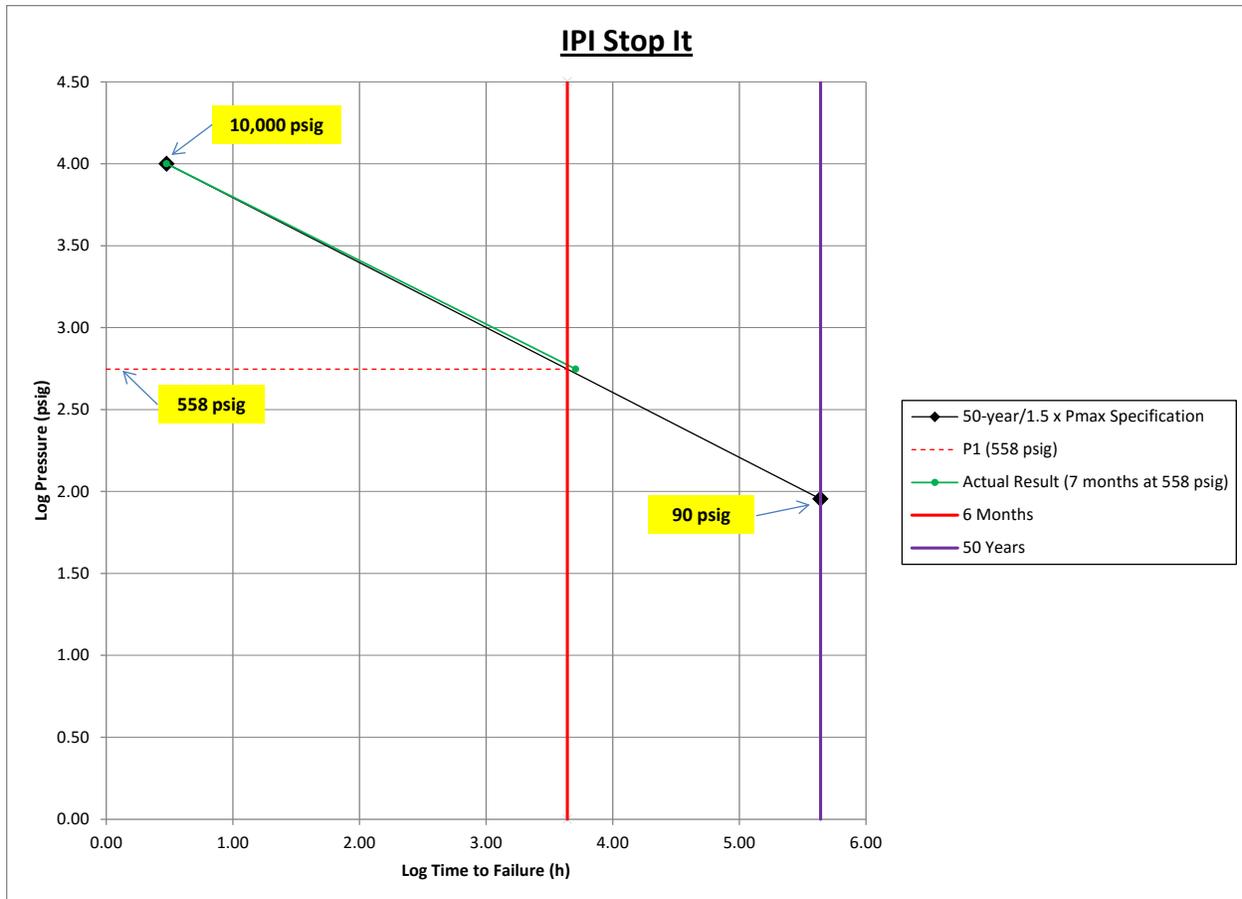
**Figure 8. Long-Term Pressure Test Results for Stop It Repaired Specimens**

None of the repaired specimens failed during this testing. A summary of the test results is provided in **Table 9**. Plots of IPI Stop It test results are provided in **Figure 8**.

For all four repair systems, the test times of the repaired specimens at each pressure level exceeded the six-month test time predicted by the 50-year/1.5xPmax line. Per GIS/LC8-1:2006 Clause D.7 this validates the integrity of all the repaired specimens over a 50-year lifetime.

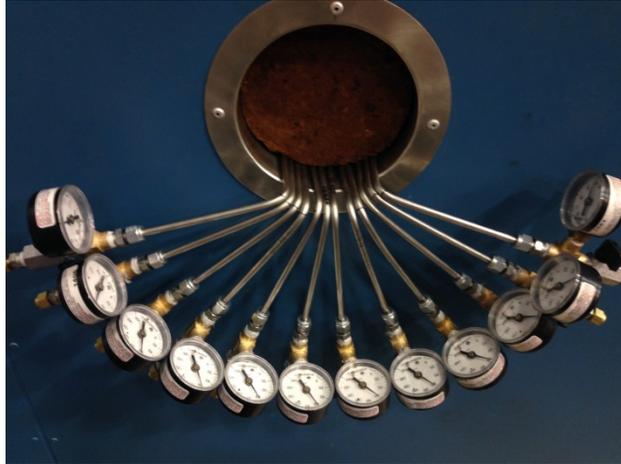
**Figure 9. Repaired Samples in the Environmental Chamber**

This test measures the capability of the repair material to withstand the effects of a fluctuating temperature environment. Three specimens of each repair system were prepared and placed inside an environmental chamber, as shown in **Figure 9**. The specimens were pressurized to 60 psig  $\pm$  4 psig and cycled through -20°F to 120°F. The temperature cycling profile is shown in **Figure 10**. The repaired specimens were tested for six months or until failure (leakage) occurred.

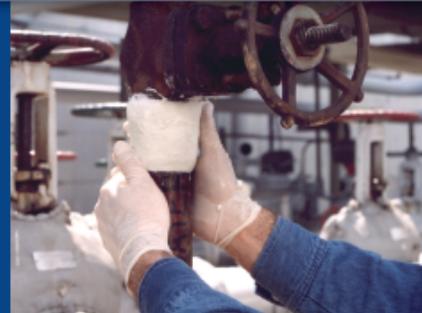
The STOP IT® Pipe Repair System includes a strong knitted fiberglass tape coated with fast setting urethane resins that are water activated. The system also includes FIX STIX™, a steel filled hand moldable epoxy that sets rock hard in only 20 minutes.
